DEPARTMENT OF INTELLIGENCE

REPORT ON THE EFFECTS AND RESULTS OF THE BOMBING OF GERMANY BY 8<sup>TH</sup>  
BRIGADE AND INDEPENDENT FORCE, ROYAL AIR FORCE: (D) AERODROMES

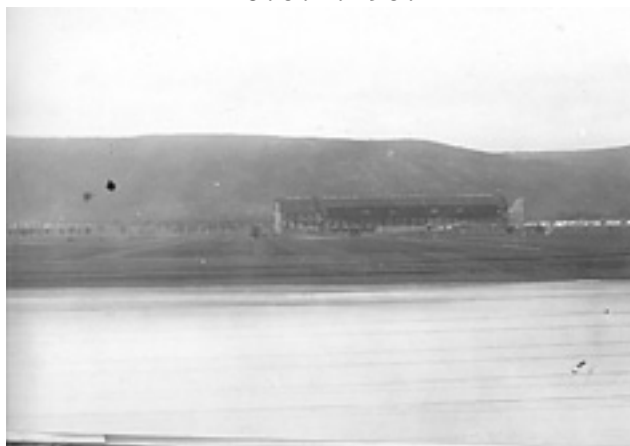
No.8.B.298.

These aerodromes were found on sites such as pre-war aerodromes, military parade grounds, and Zeppelin shed enclosures, (see photo No. 8.B.298), situated near broad main roads and railways.

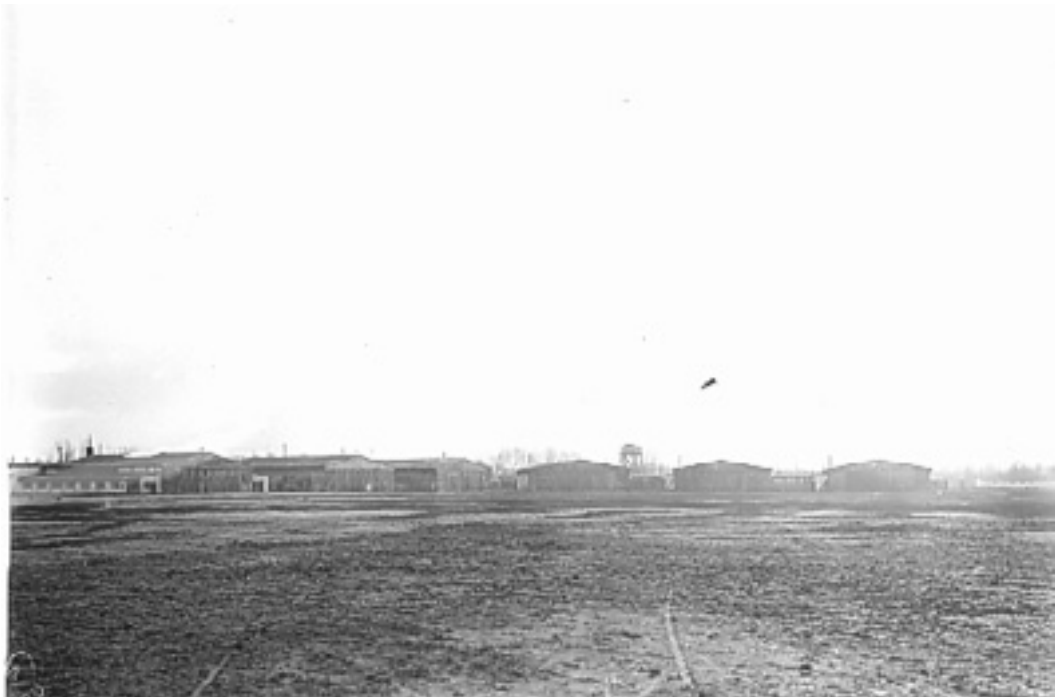
No. 8.B.313.

It is interesting to note that the possibility of these permanent aerodromes being attacked does not appear to have influenced the enemy in the erection of his hangars or buildings, which were placed close together. (See photos. Nos. 8.B.313, 318, 319, 287).

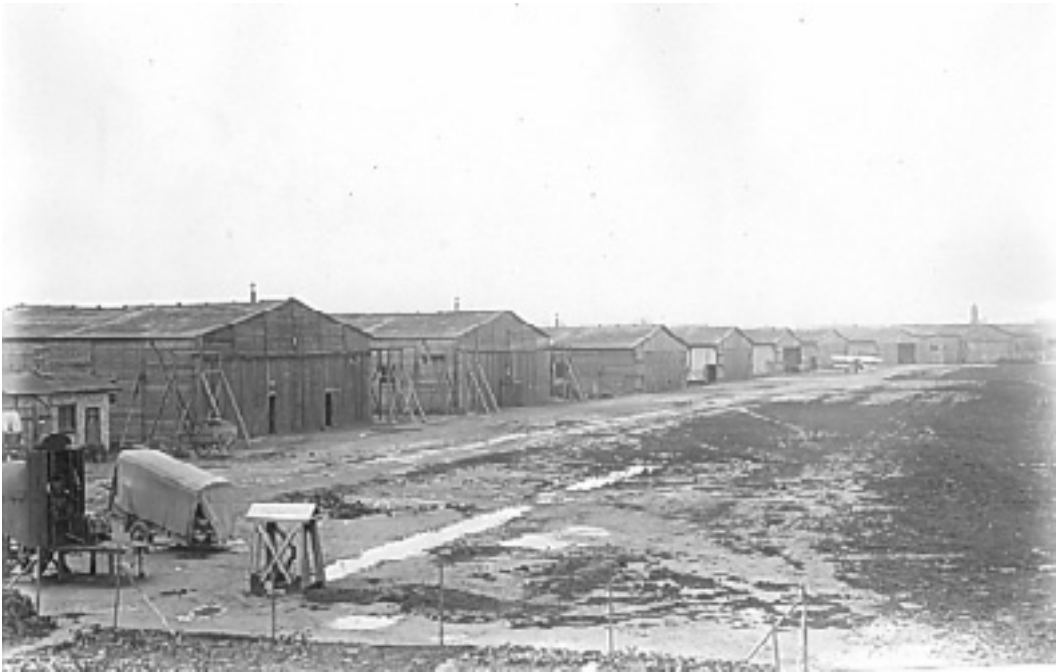
No. 8.B.319.

This type was like a house with roofs sloping from the centre down to the side walls. (See photographs, Nos. 8.B.314, 317, 319 and 335. For Nos. 314 and 319 see pages Nos. 9 and 3 respectively).

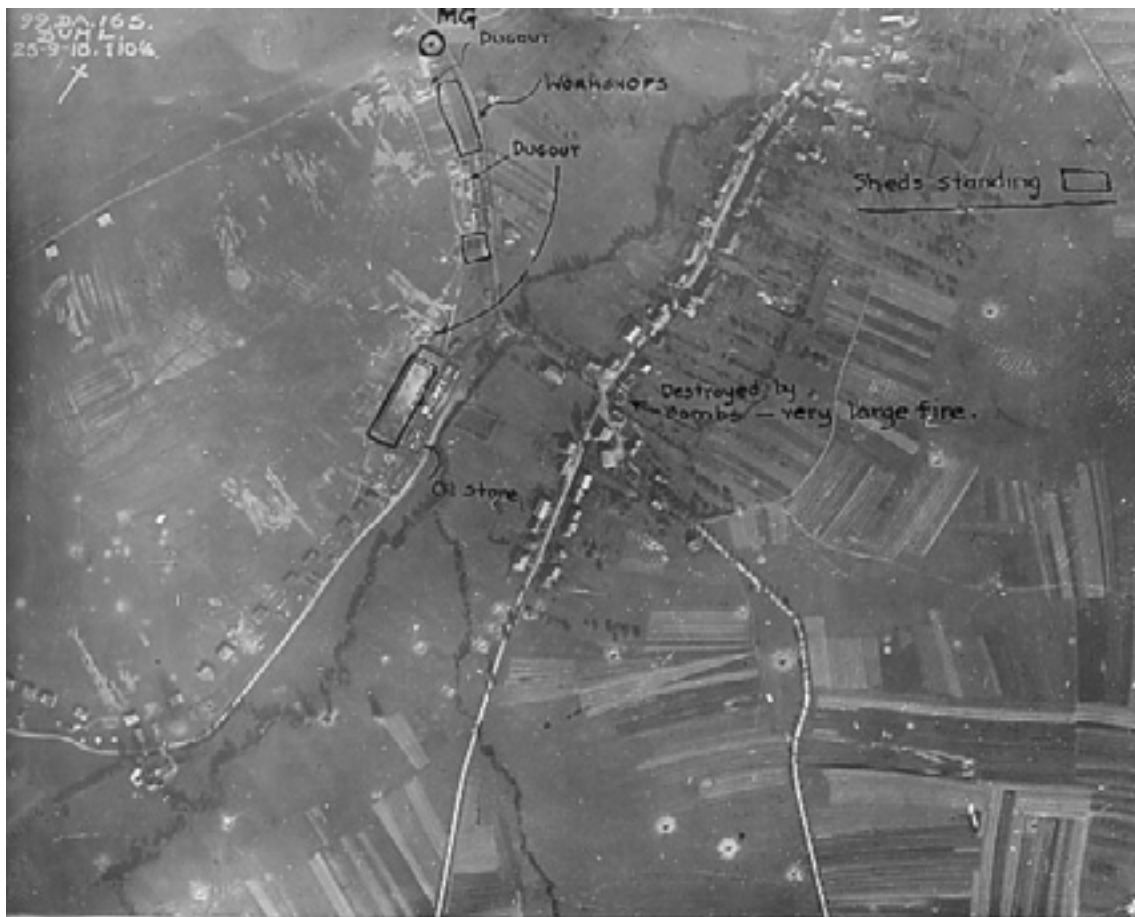
No. 8.B.406.

Only one shed had been completed, the other two had only been started shortly before the Armistice. Their location can be seen from the attached photograph. (No. 8.B.406).

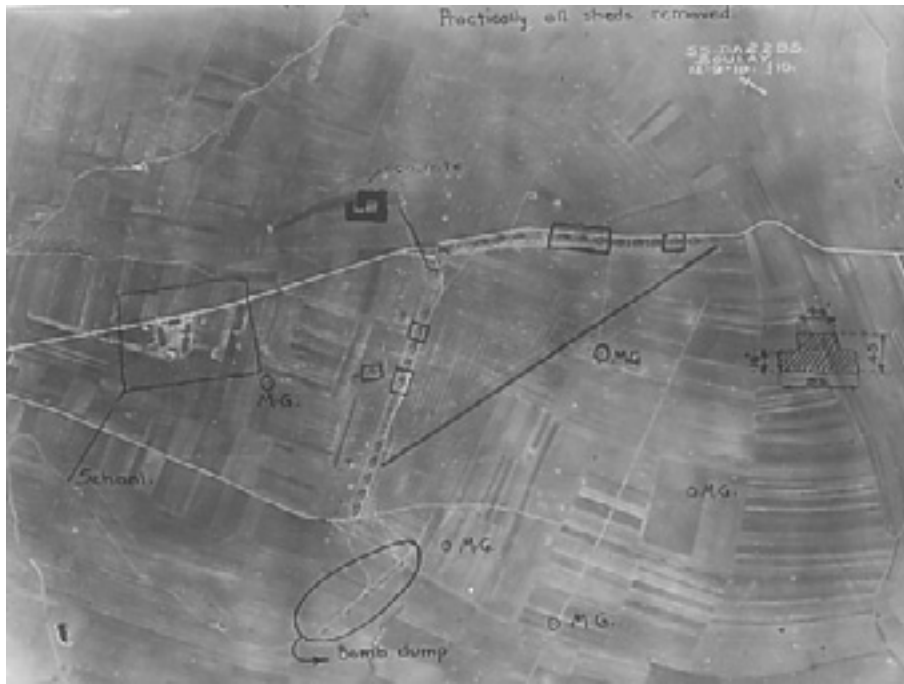
No. 8.B.408.

There were no signs of overhead cover of any description having existed. From the photograph (No. 8.B.408 - see page 6) it will be seen that they were situated close to such living huts as did exist. It is possible that this was considered by the enemy to be sufficient protection for the small number of men left on the aerodrome at night.

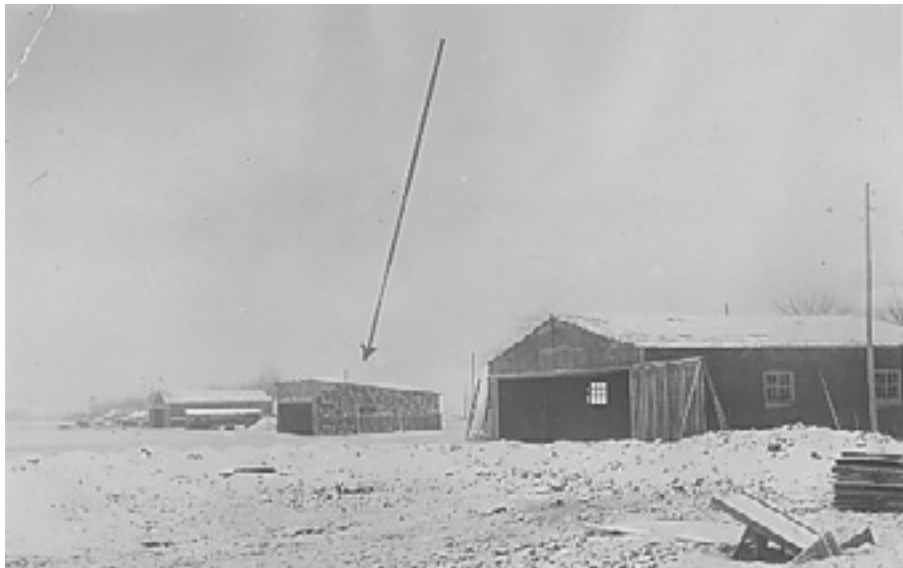
a). The most common type of hangar used by the Germans is shown in photograph No. 8.B.336.

These hangars are built entirely of wood and are 35 feet deep by 50 feet wide. At the open end they are 14 feet high, with doors 10 feet high. The roofs slope back to the rear wall of the hangar, which is 11 feet high. These hangars are collapsible and can be taken down or erected in a very short time. A good idea of the method of construction will be gained from the attached photographs (Nos. 8.B.334 and 338).

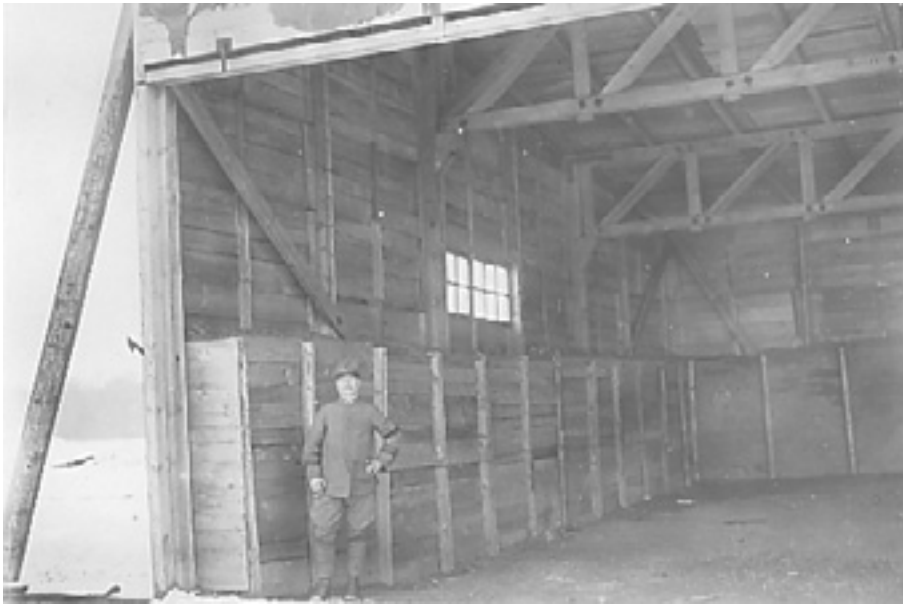
No. 8.B.334.

In the centre of each hangar a pit had been dug about 9 feet wide and sloping from the front edge to a depth of about 3 feet. The total length of the pit is about 20 feet.

These hangars are all protected with a revetment varying from 6 - 8 feet in height, and 2 feet in breadth. The revetting is found sometimes outside, sometimes inside, the hangars, and at MORHANGE aerodrome the revetting in the case of some hangars was found to be alternately inside and outside.

(See photographs, Nos. 8.B.334 and 338, above).

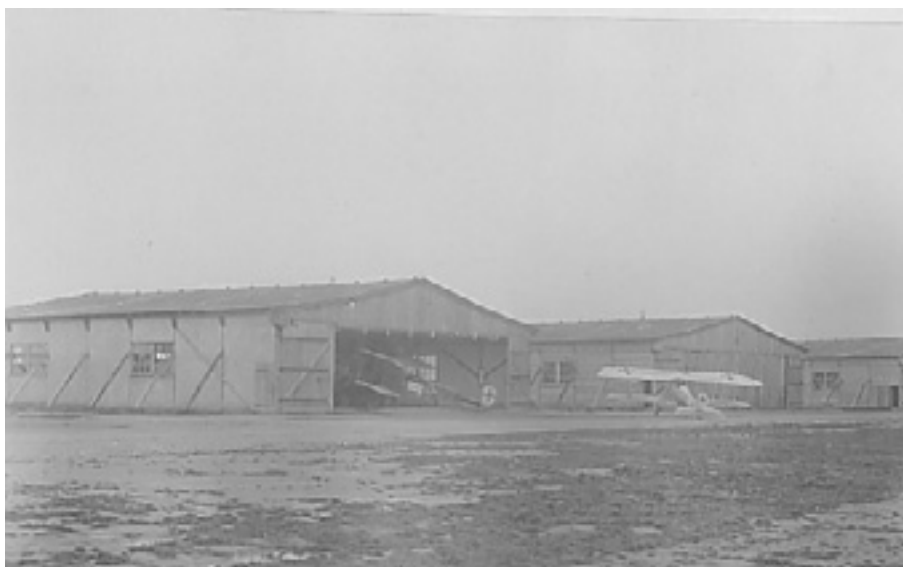
No. 8.B.317.

The structure was 60 feet square, with walls 15 feet high, and 18 - 20 feet high in the centre. The entrance was approximately 13 feet high with folding or open doors. In some cases the doors were opened outwards and downwards.

The construction of these hangars varied in few details. Some were found to be constructed entirely of wood, others had wooden roofs and doors, with plaster and cement walls.

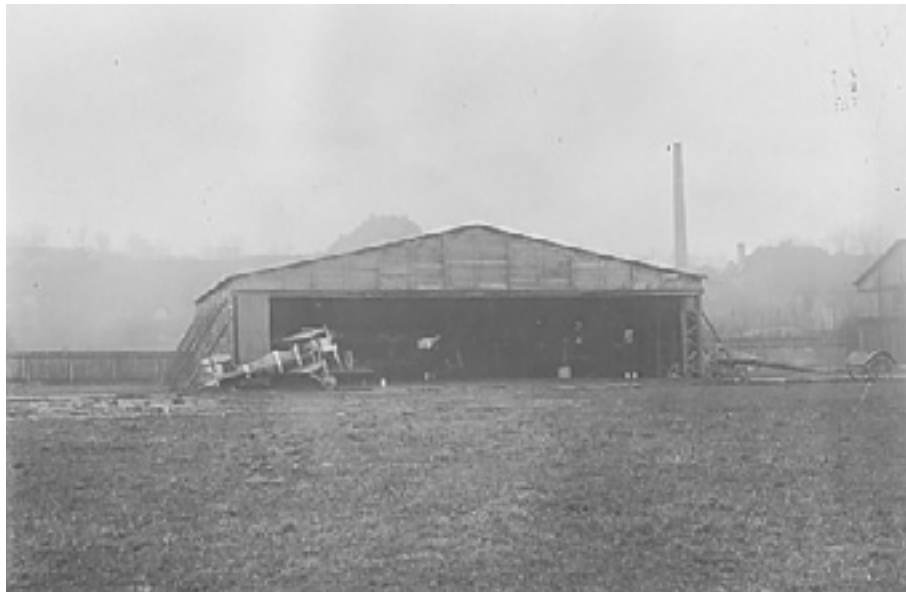
No. 8.B.293.

Hangars of this kind were found at MORHANGE, DESTRY, SAARBRUCKEN (See photo. No. 8.B.293), MAYENCE, SPEYERDORF and GERMERSHEIM.

They were not always for the housing of machines; some were used for stores and spare parts. On aerodromes near the front it was unusual to find more than two hangars of this nature. (MORHANGE, 2.). It must be admitted that they were remarkably well erected and fitted up with all necessary appliances.

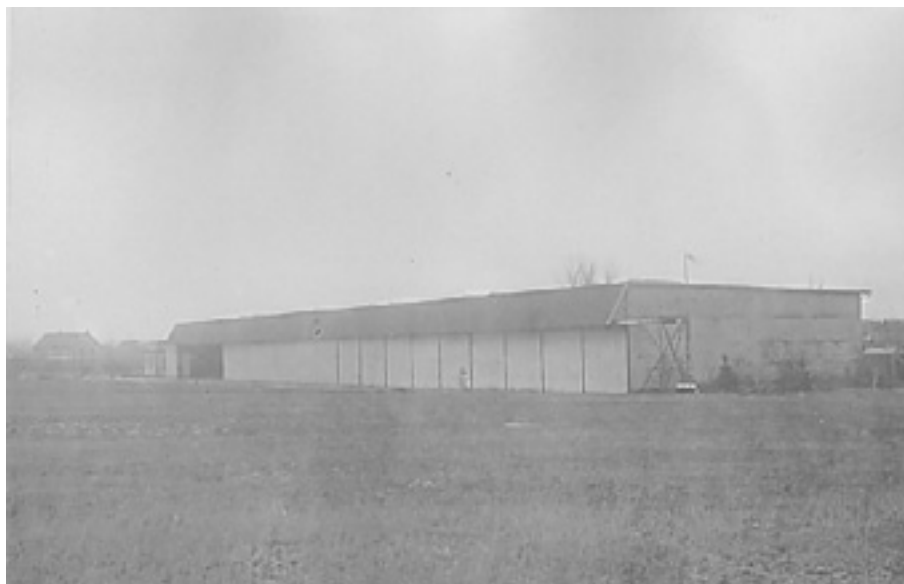
No. 8.B.275.

c). This type of hangar was generally of a very permanent nature. It had a brick foundation standing 6 feet above the ground, which carried walls of plaster intermingled with cement. The roofs were supported on steel and appeared to be made of concrete or thick corrugated iron. In some cases the walls and roofs were made of wood and steel, but cases of this were rare. The floors are concrete throughout. The large doors on the front of the sheds were steel and in some cases collapsed sideways in a combined folding and sliding fashion; in other

cases they opened downwards and outwards. Lighting was provided in large glass windows in the front and rear of the hangars which ran continuously throughout its length. (See photos. Nos. 8.B.275, 316, 282).

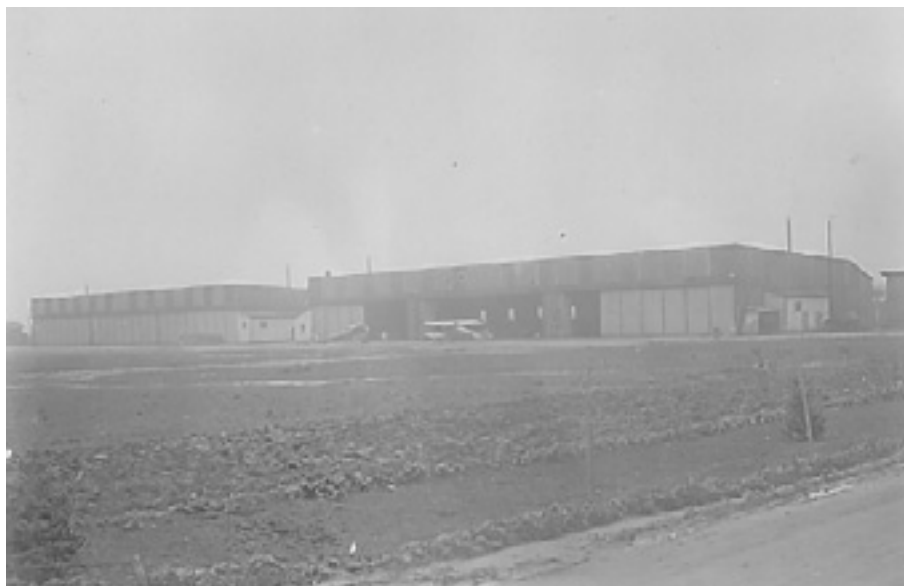
No. 8.B.316.

In other cases hangars had one large and ten small windows alike in the front and rear wall of the hangar. (SPEYERDORF. See photo, No. 8.B.316). The roofs were ingeniously designed to provide for this light as shown in the sketch :-

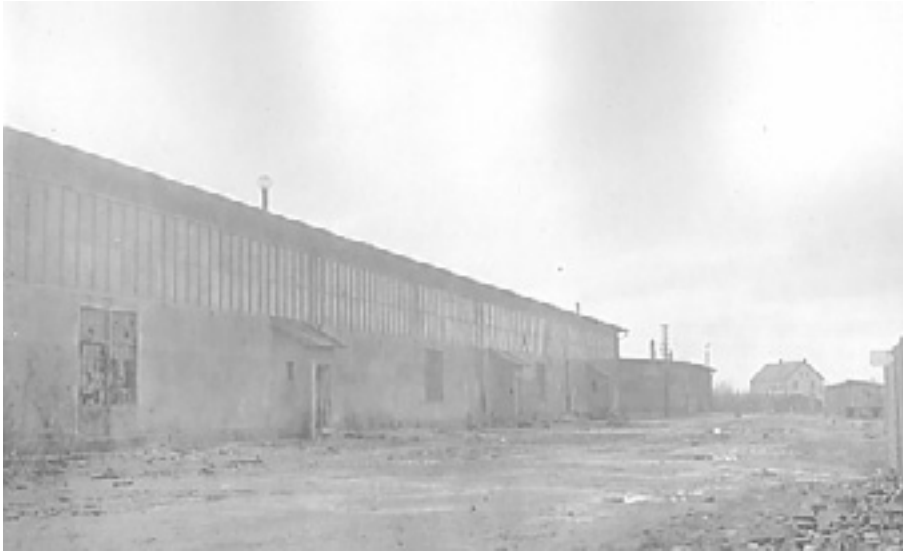
No. 8.B.266.

At BUHL the large hangar was lighted by means of windows in the roof as well as the sides. (See photo. No. 8.B.266).

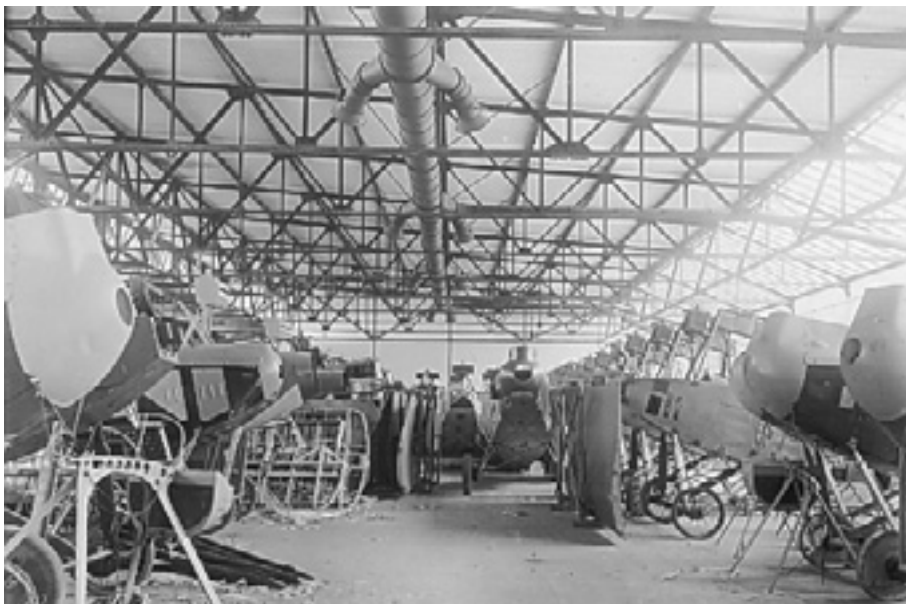
No. 8.B.327.

For heating of the hangars, large pipes with funnelled branches were provided for dispersing hot air. These pipes were carried in roof trussing. (See photo. No. 8.B.327).

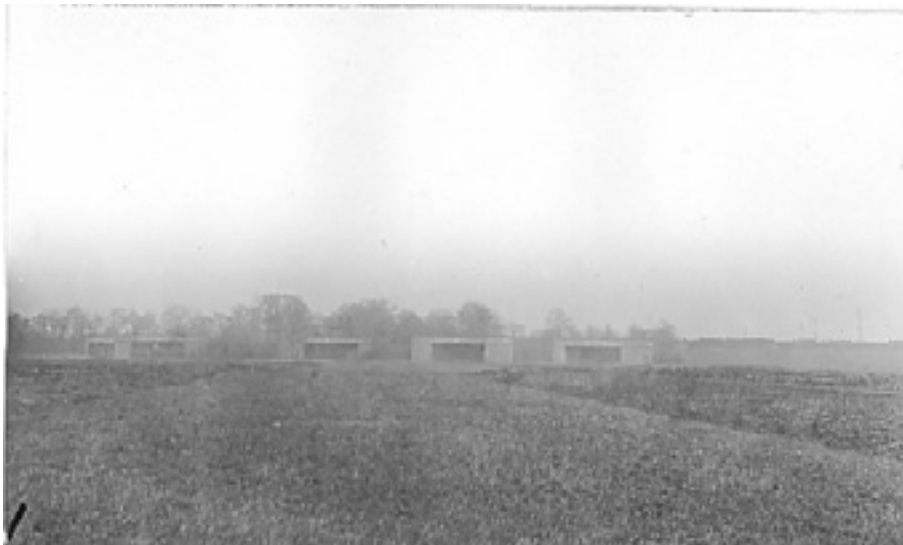
No. 8.B.361.

d). This type of hangar appears to have been used on aerodromes intended for the use of bombing machines, and was only found at BOULAY and THIONVILLE. (See photos. Nos. 8.B.361, 359, 358).

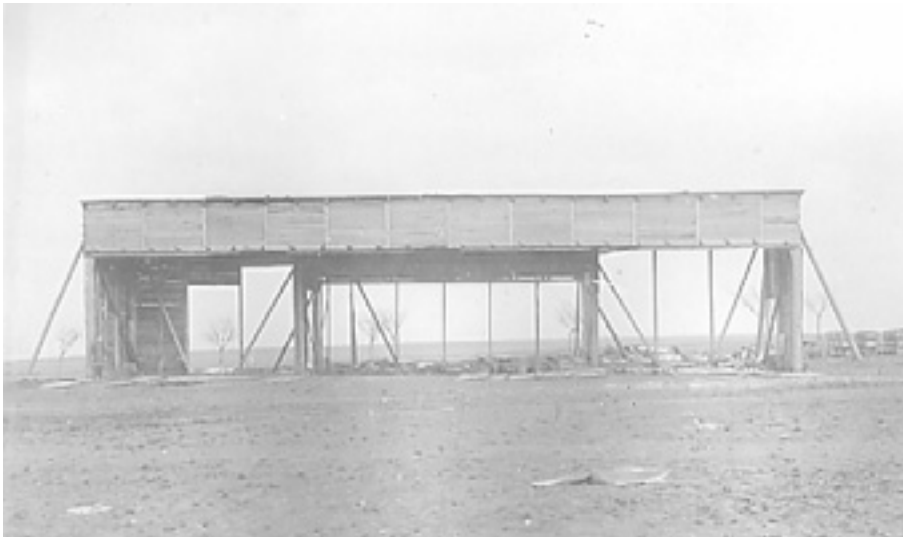
No. 8.B.376.

The aerodromes which were not visited, VILLIERS LA CHEVRE and COSNES, are known to have been similarly equipped. In shape the hangar somewhat resembles a capital 'T'. Its approximate dimensions are as shown in the sketch :-

(See photos. Nos. 8.B.376, 372.)

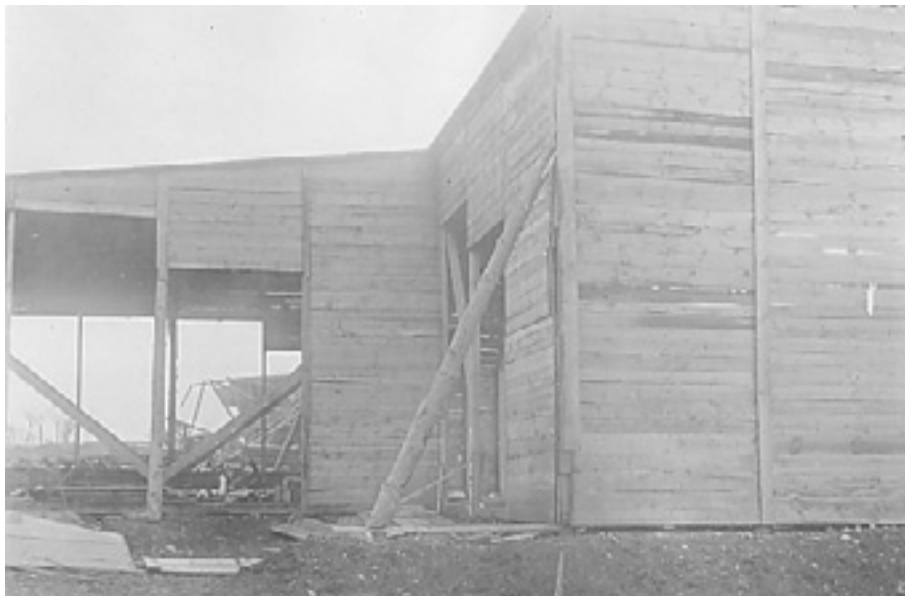
No. 8.B.374.

The height of these hangars was about 35 feet, the roofs being covered with tarred felt. The framework, roof and sides, as may be seen from the photographs, were entirely of wood, cut in beams and strips and fitted together by means of bolts and screws. (See photos. Nos. 8.B.374, 285, 283).

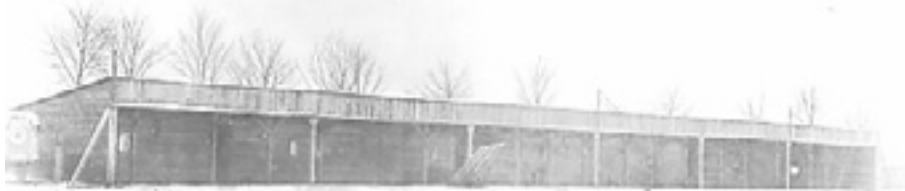
No. 8.B.330.

e). Hangars of this type were not so common, and were seen only at MORHANGE and MONTROY aerodromes. (See photos. Nos. 8.B.330, 333).

They consisted of wood throughout and varied in length from 30 to 60 feet, being 10 to 15 feet broad, and 18 feet high in front, with a sloping roof to the back wall which was 10 feet high.

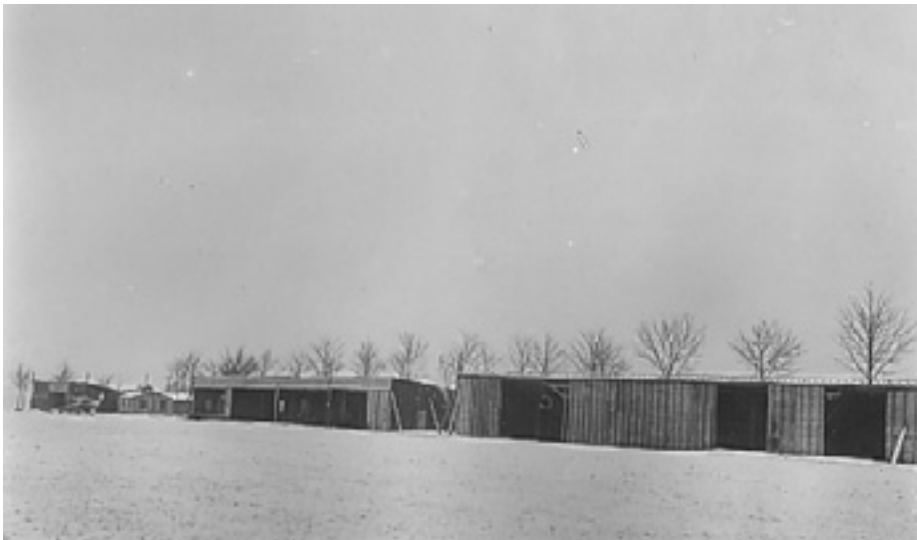
No 8.B.333.

There were no compartments, and the hangars were capable of housing from 10 - 15 machines, but it is thought that they may have been used for lorries.

The floors were of wood and the doors opened outwards and downwards. No lighting of any kind was found other than that provided by the entrance.

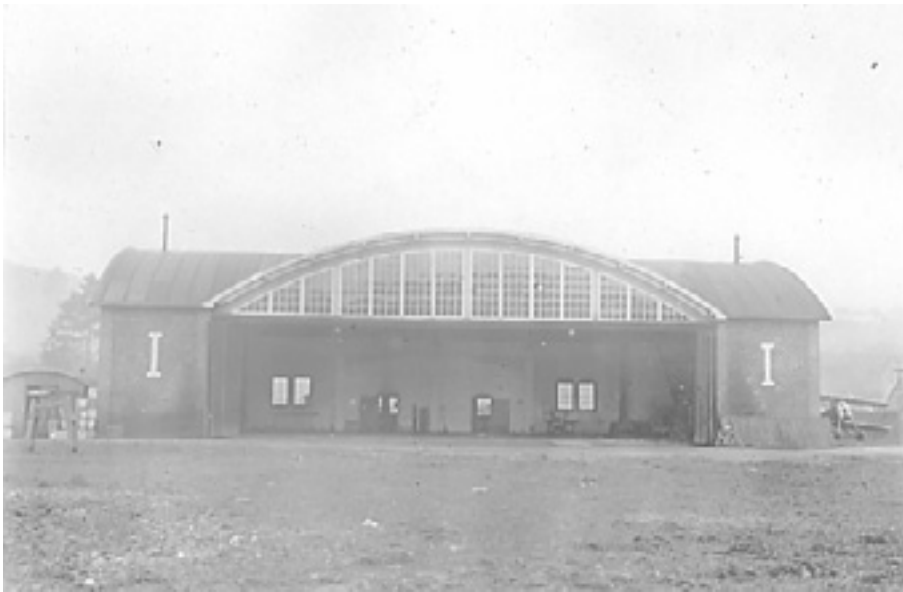
8.B.294.

f). This species of hangar was only found at SAARBRUCKEN aerodrome and, as will be seen from the photograph (No. 8.B.294) was of a permanent type.

It was most solid in its construction, and had a floor of concrete and was very well fitted up, lighted and heated.

Only curtains were used to cover the entrance of this hangar, although it was originally fitted to take sliding corrugated iron doors. Its housing capacity was 10 machines.

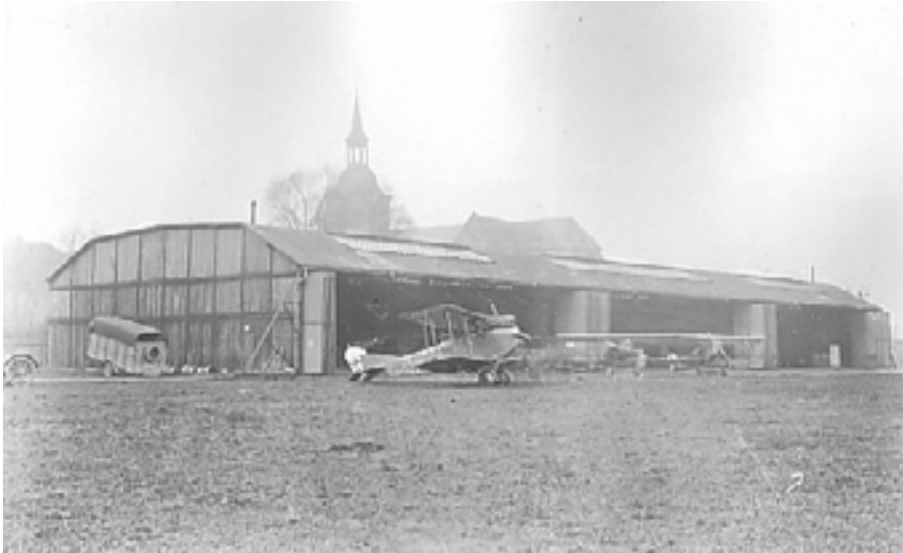
No. 8.B.292.

It was capable of accommodating 30 machines, was well lighted and heated, and the internal installations were good. The floor was of concrete.

The method of closing the doors of the hangar is interesting. They consisted of corrugated iron strips, all joined and hinged together, which, when opened up, assumed a concertina shape.

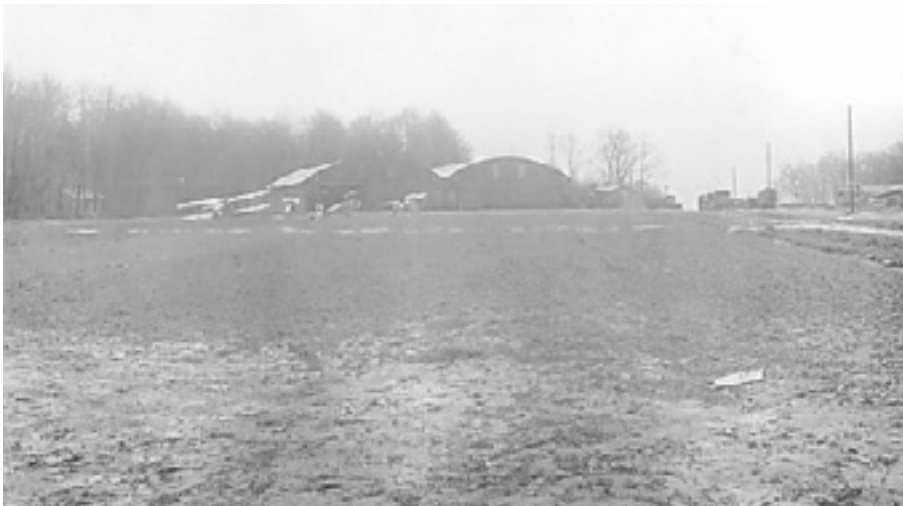
No. 8.B.267.

FOLPERSWEILER aerodrome provided the only sample met with. It will be seen to consist of two hangars joined together. They were made of wood with corrugated iron roofing and doors, had concrete flooring, and workshops were attached to either side of the hangar in lean-to sheds.

These hangars did not, as a general rule, house machines, as it was here that a large proportion of the repairs was carried out. There was no revetment of any kind, but heating was provided. Natural lighting was not so good as in other hangars visited, but electric light had been installed and was being used by the French when the aerodrome was visited.

Only a very small portion of this camp is visible on the photograph and it provides the one and only example met with of successful aerodrome damage. (See photo No. 8.B.267).

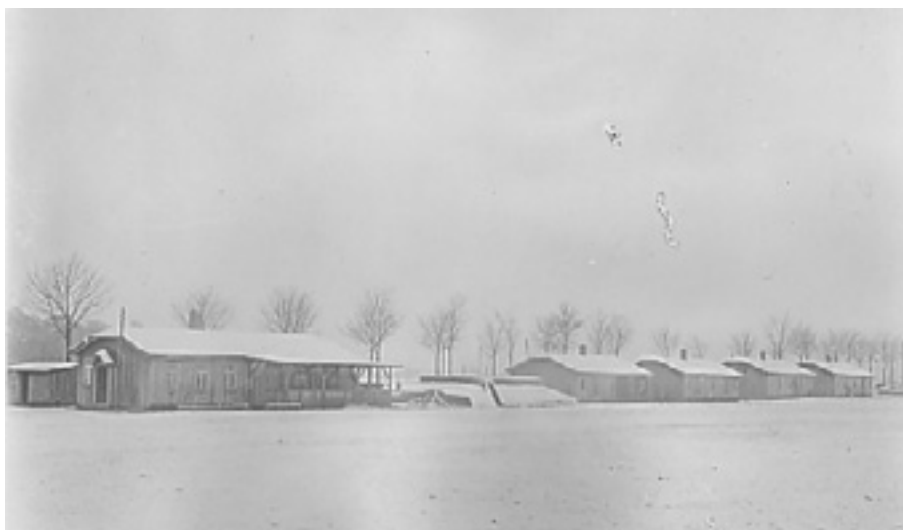
No. 8.B.332.

Little need be said of the enemy's housing installations. From the attached photographs it will be seen that they were of solid construction. Photograph No. 8.B.332, shows the living quarters of the officers at MORHANGE.

Each hut has four rooms and a washing room, and is well fitted up. Photograph, No. 8.B.312, shows the officers' mess, and living quarters of the 7<sup>th</sup> Bavarian Military Flying School.

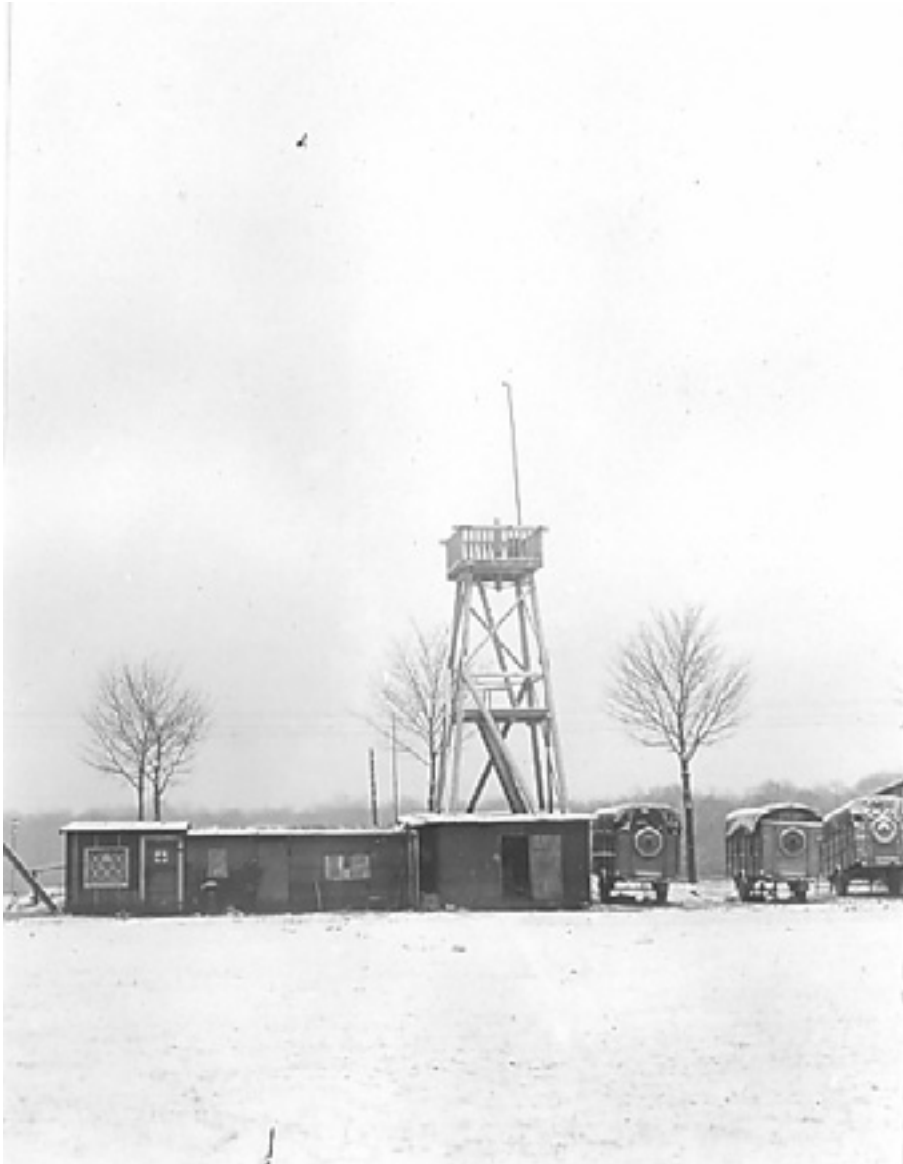
No. 8.B.329.

Photograph, No. 8.B.329, shows the control platform at MORHANGE aerodrome.

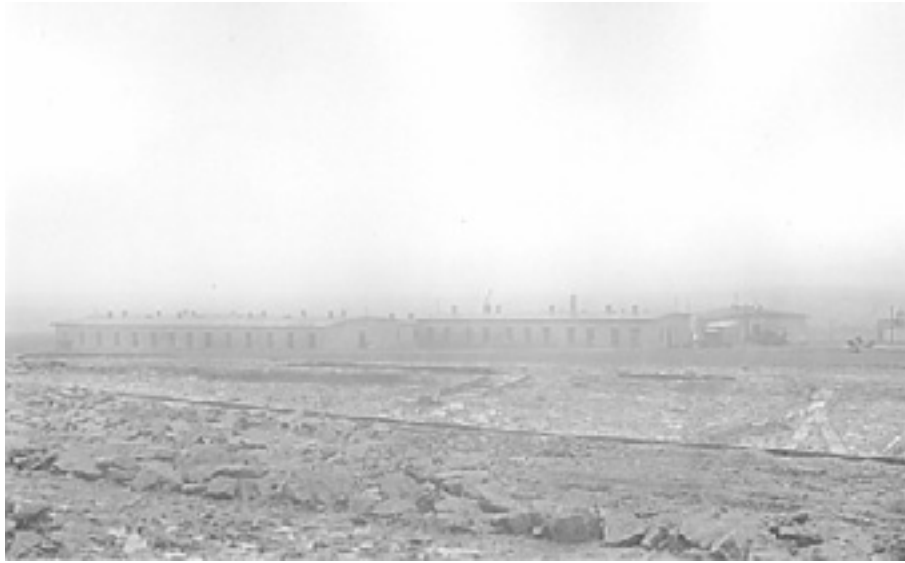
No. 8.B.351.

Photograph, No. 8.B.351, shows the Training School, still in the course of construction at BOULAY.

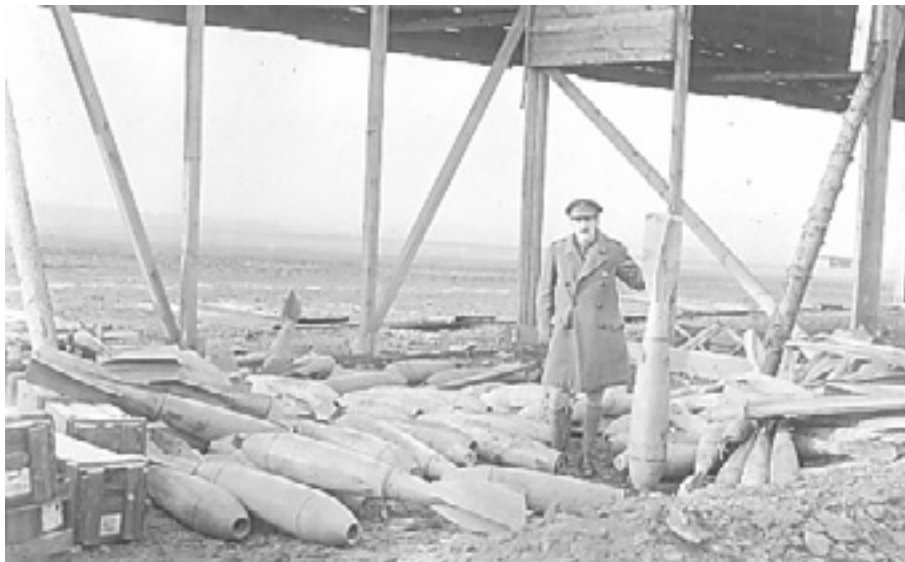
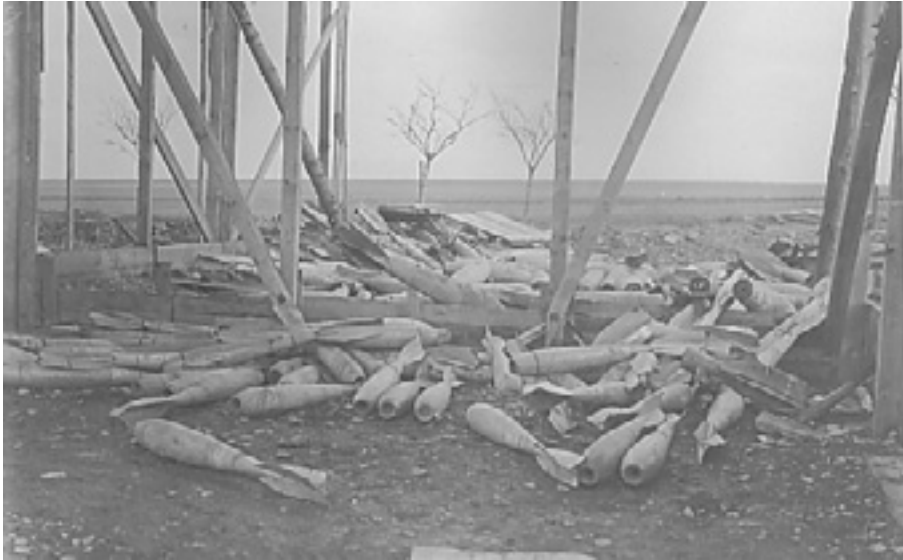
No. 8.B.375.

Photographs, Nos. 8.B.375 and 377, show types of bombs used by squadrons operating from BOULAY.

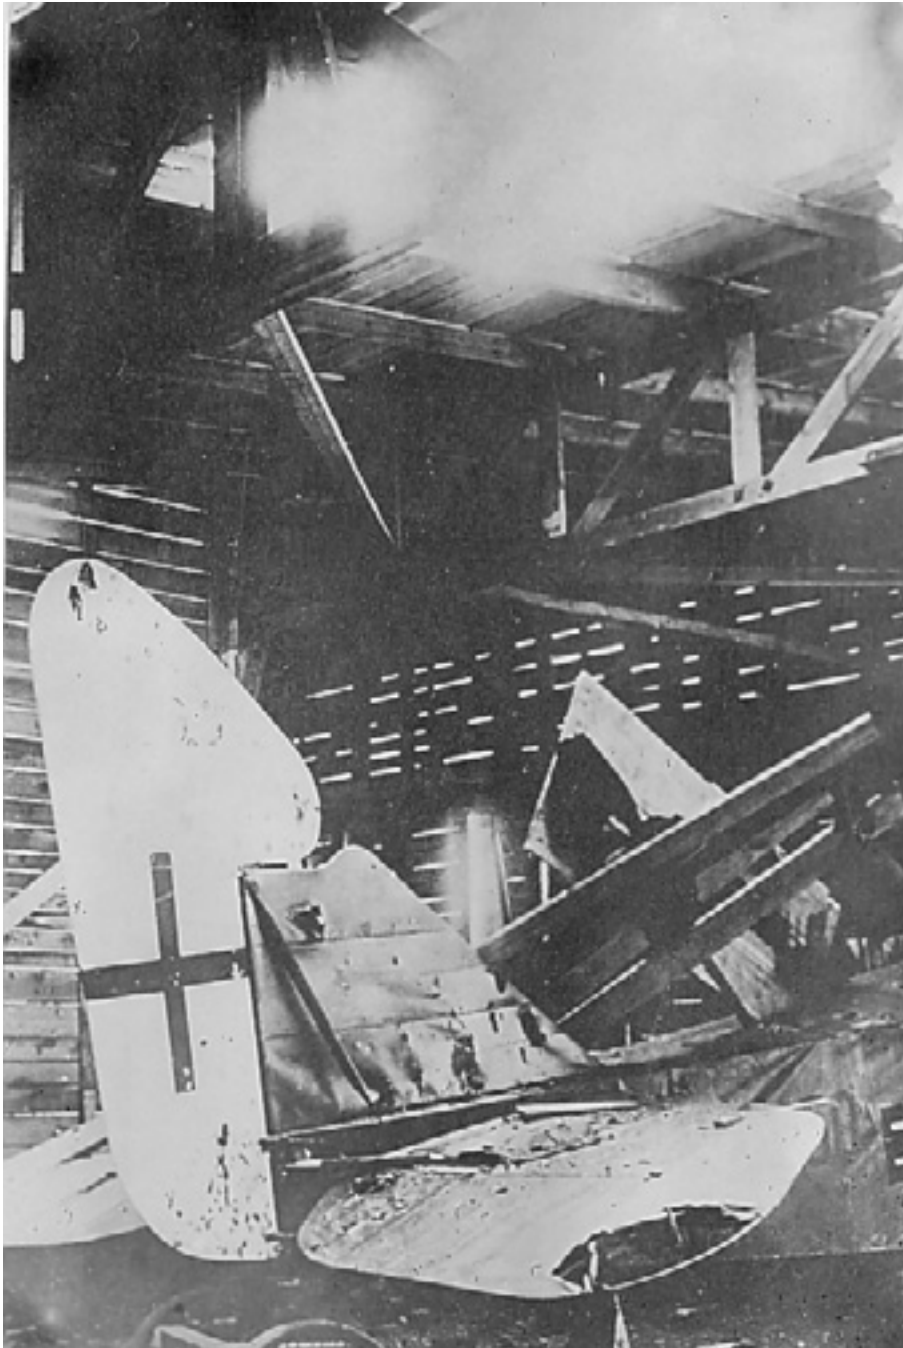
No. 8.B.101.

suffered considerably. Almost every hangar had received a direct hit. Even if hangars were not hit, and bombs exploded outside, the splinters seriously damaged the machines and rendered them useless for any flying until repaired. The effect of splinters on machines may be judged from the attached photographs (Nos. 8.B.101, 362, 360, 355).

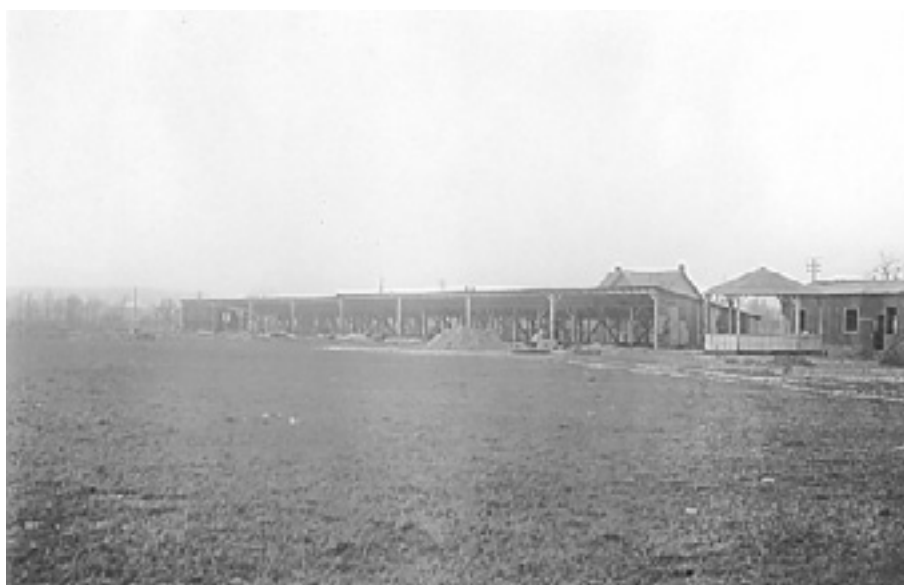
Several bombs had fallen in front of the large hangar at BUHL, but there was no sign of any direct hit having been secured. The workshops at BUHL had been damaged from time to time, signs of which are still visible. (See photographs, No. 8.B.353).

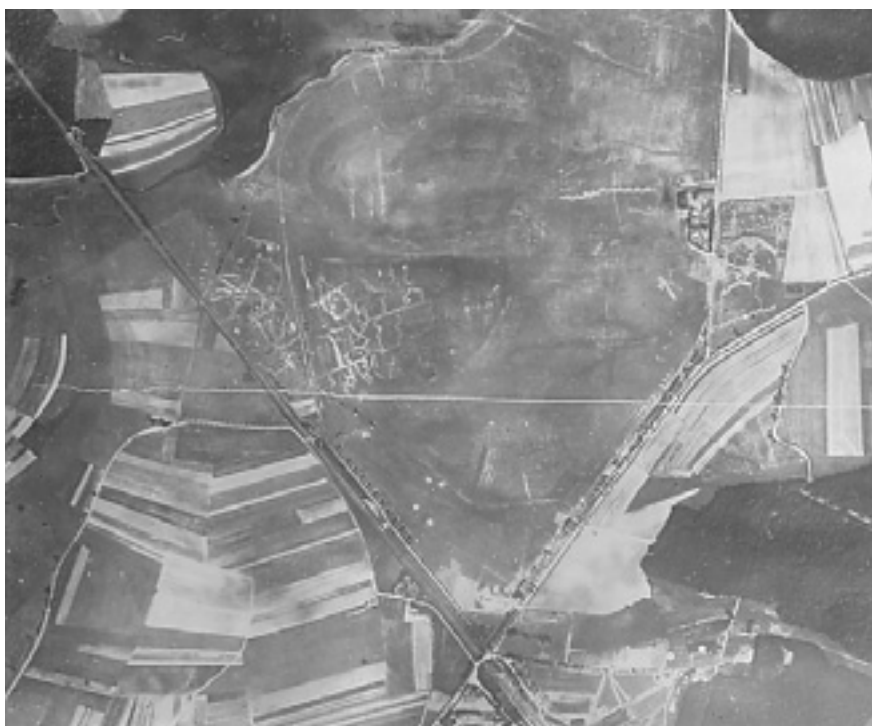
No. 8.B.414.

The above is of interest and is confirmed by aerial photography. (See photo. No. 8.B.414).

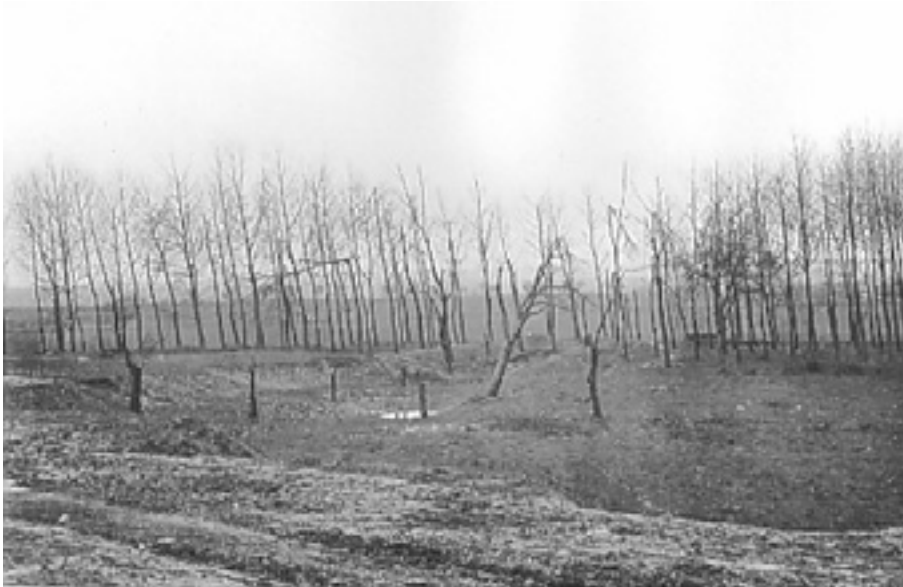
No. 8.B.68.

On the night of 22/23<sup>rd</sup> August, 1918, hostile machines bombed the aerodrome and caused an enormous fire which could be seen for miles. This fire appears to have resulted from the ignition of a large petrol dump situated in the small triangular wood to the S.W. corner of the aerodrome. The locality where this petrol was stored is about 50<sup>x</sup> by 15<sup>x</sup> and even now a gap about double this size is to be seen, with two fair sized holes in it. (See photo. No. 8.B.68.)

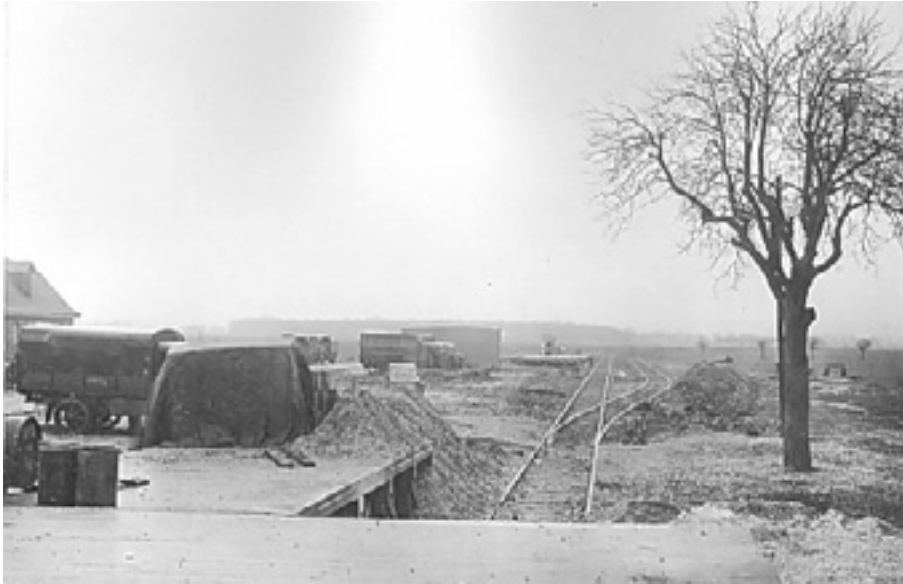
North of this wood and in the triangle is a long military loading platform near the railway. On this there were some munitions (bombs ?) and bombs appear to have struck this and exploded it. The result was that 100 feet of this platform ceased to exist. (See photo. No. 8.B.400).

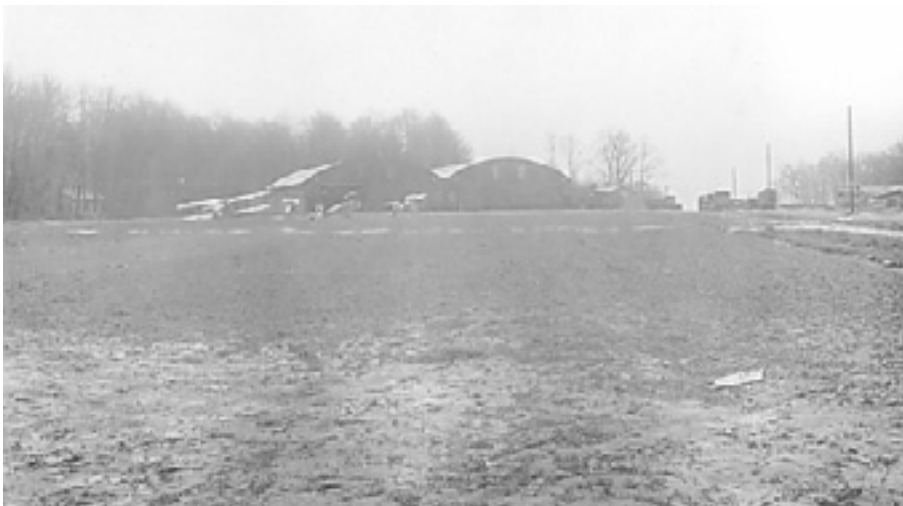
The civilians were very enthusiastic over this raid, and said that they had hoped an attack would be made on the living quarters of the officers and men located in the wood N.W. of the triangle. There were over 20 huts here with accommodation for 300 men. Some of these buildings were of brick and very substantial. In the compound was a large messing and recreational hut about 100' by 40'. Dugouts were also found.

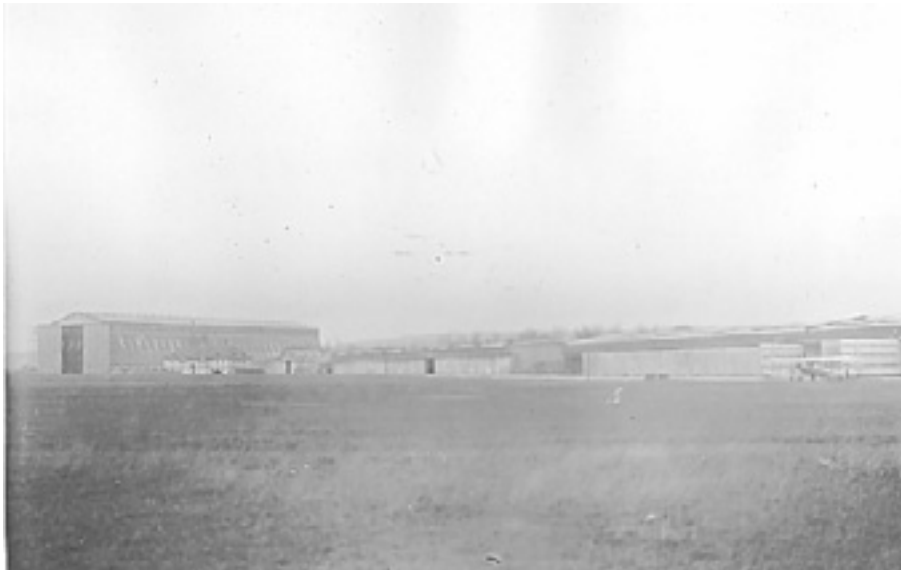
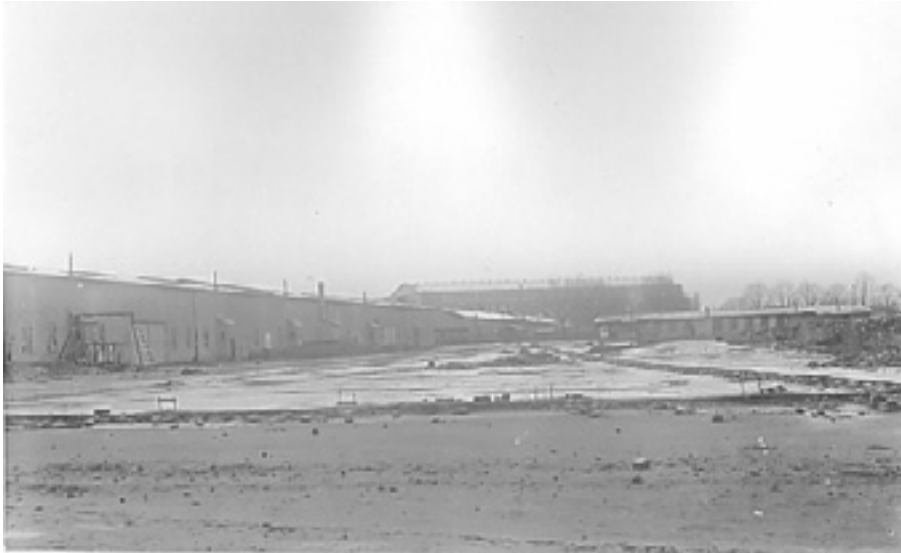
No. 8.B.270.

On the night of 26/27<sup>th</sup> February, 1918, bombs were dropped on FRESCATY aerodrome. These bombs set light to the large rear hangar, 100 yards long by 20 yards broad. All the machines inside were burnt. (See photos. Nos. 8.B.270, 401).

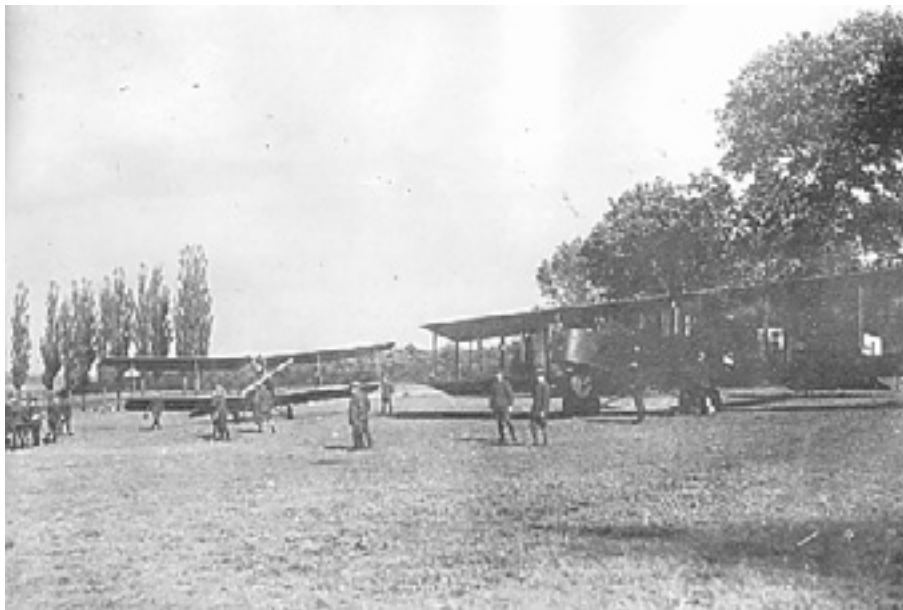
No. 8.B.118.

He was bombed here, and as a result of this and the wet nature of the ground he abandoned this aerodrome. He then chose LELLINGEN aerodrome, and, as could be seen from aerial photographs, this time took the precaution of scattering his hangars. Here also he was found and again bombed. The soil was of a very wet nature, and he finally decided to leave it. RUPLINGEN aerodrome was his last choice but no hangars were erected. (See photograph, No. 8.B.118).
