DEPARTMENT OF INTELLIGENCE

REPORT ON THE EFFECTS AND RESULTS OF THE BOMBING OF GERMANY BY 8<sup>TH</sup>  
BRIGADE AND INDEPENDENT FORCE, ROYAL AIR FORCE: (D) AERODROMES

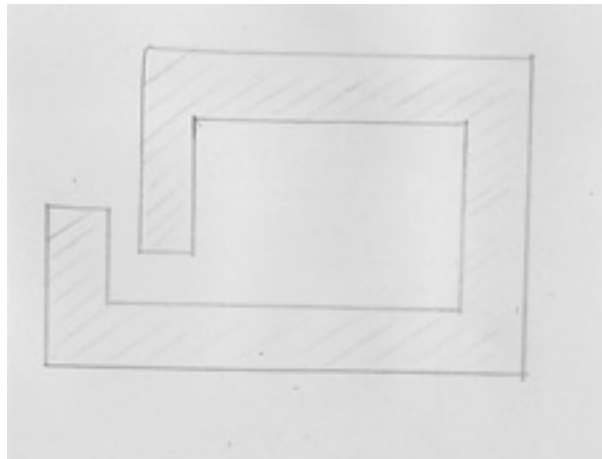
Protective measures at this aerodrome were not found to be in an advanced state. The dugouts were poorly constructed and were more in the form of "above ground shelters" than dugouts. Three of these peculiar structures were located close together where two lines of hangars converge. They were built of concrete with walls 18" thick and 7' high. Only 1' 6" of these walls was sunk below the ground level. Their construction and shape are roughly as shown :-

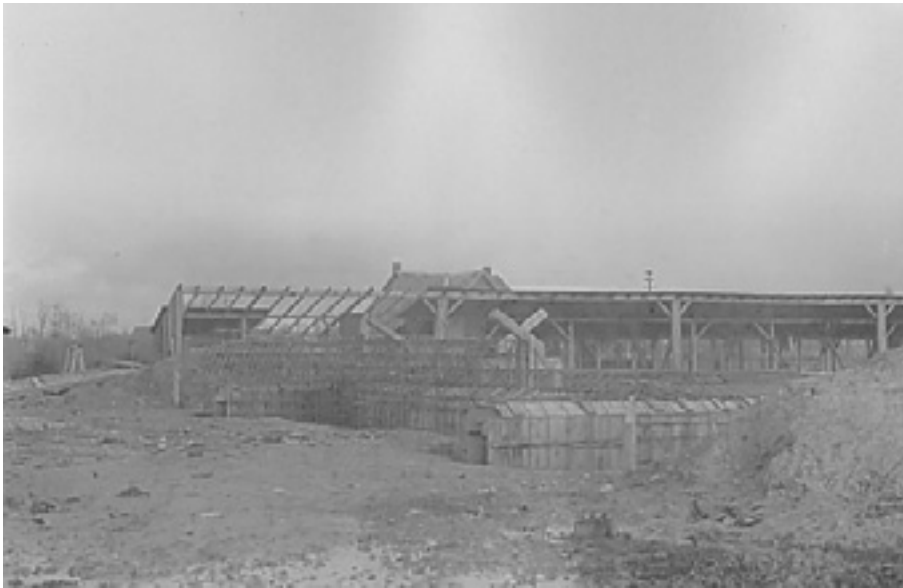
No. 8.B.289.

At this aerodrome most elaborate dugouts have been constructed. (See photographs, Nos. 8.B.289, 350, 354).

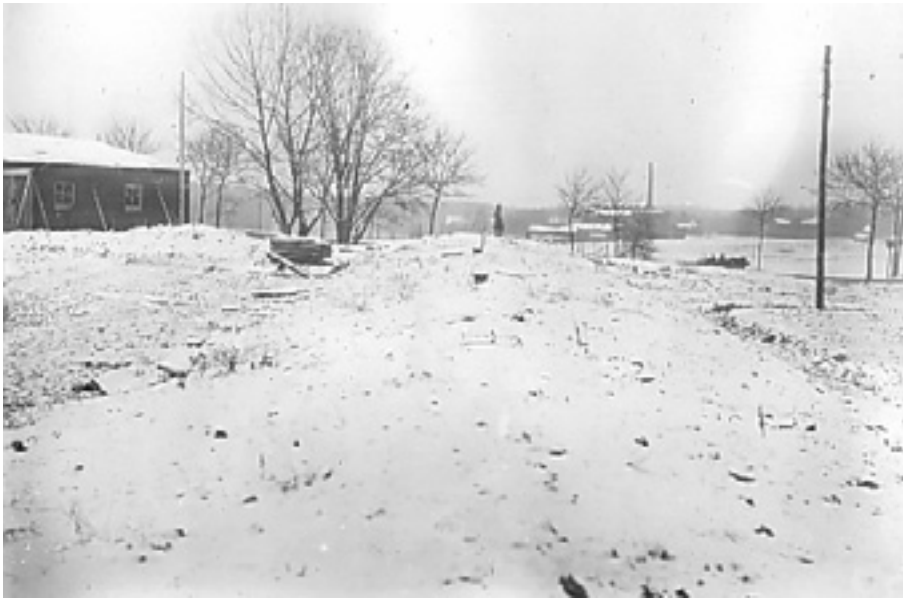
No. 8.B.331.

There were two different types of dugout at this aerodrome. It must be remembered that the hangars at this aerodrome were revetted but the living quarters were not. One dugout, which had been built some considerable time ago, was found at the Southern end of the aerodrome near the railway. This is clearly visible on the photographs, and is 200 feet long by 20 feet broad, being sunk to just below the level of the ground and with earth piled on the roof. The inside was propped with wooden struts, and consisted of several small rooms, all of which were connected by one long passage. There were openings and several windows well below the level of the ground (see photos. Nos. 8.B.331, 337).

This dugout had been hit and penetrated by what appeared to have been a 112 lb. bomb.
